# **30th Anniversary Isle of Mull Rugby Club Improving Facilities for Mull**

27th October 2009

# Improvements to the Isle of Mull's Sports Facilities

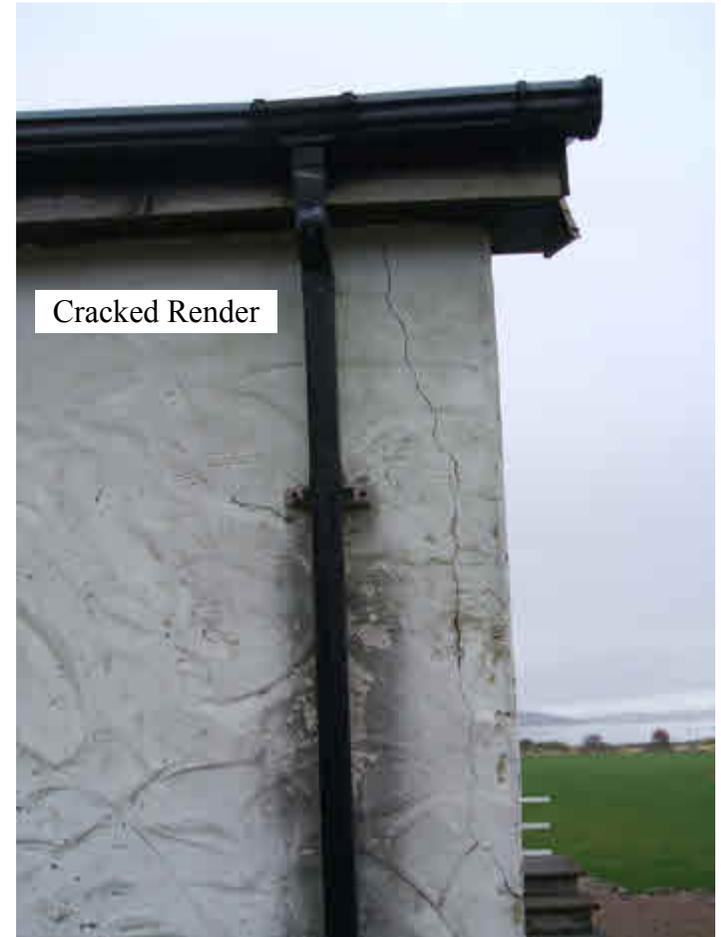
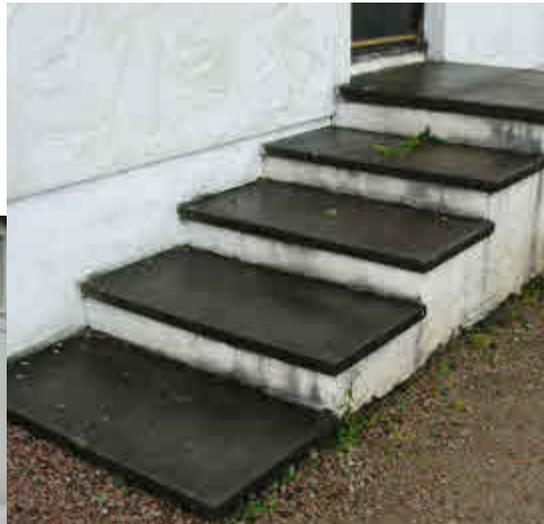
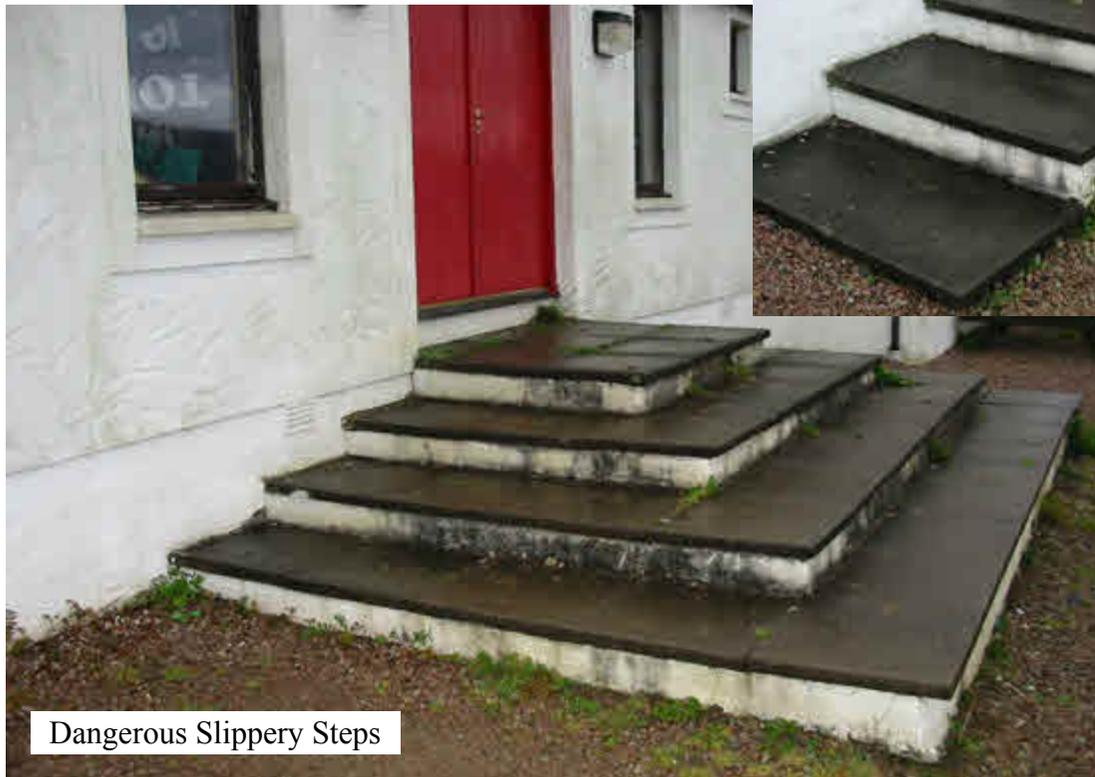
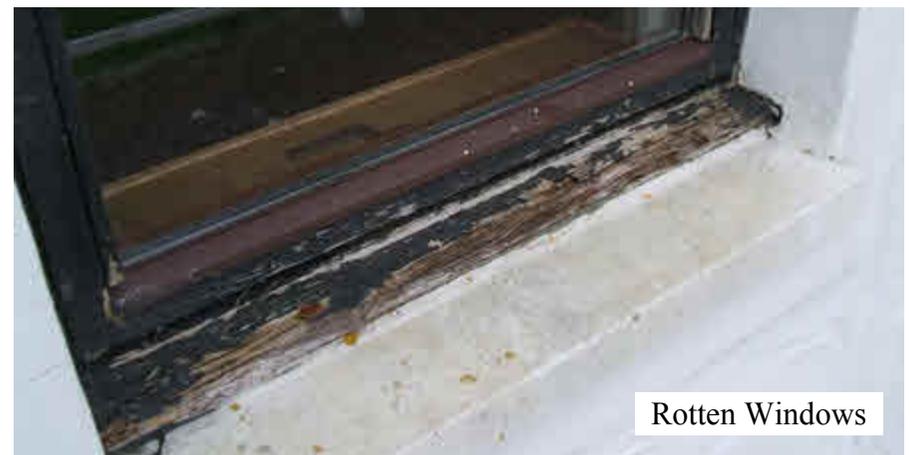
The surface rendering used white silicon sand mined at Lochaline. The was the only sand available at the time. The sand was too fine and has cracked in many places over time. Weatherproofing is severely compromised and the insulation of the walls is badly affected.

There is a also general need to improve thermal insulation to the walls and roof. For example there is none over at least 50% of the roof space.

The windows are showing considerable signs of rot and need modern double glazing to improve the heat retention of the building.

Due to an elevated internal floor steps, lead down from the front door and the two changing rooms. This is very dangerous, particularly when players leave the changing rooms wearing boots.

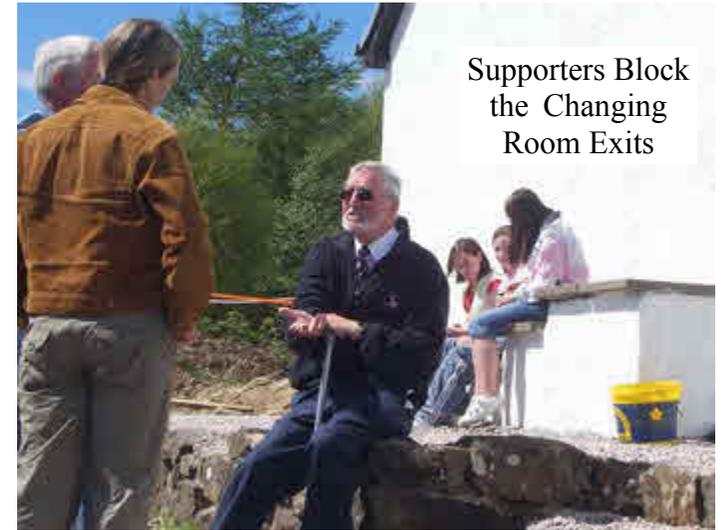
The steps to and from the changing rooms are a magnet to casual seating. This often causes blockages to participants coming and going. The steps are also a physical barrier to inclusive community sports use i.e. the disabled, the elderly, and younger sports participants.

Supporters Block the Changing Room Exits

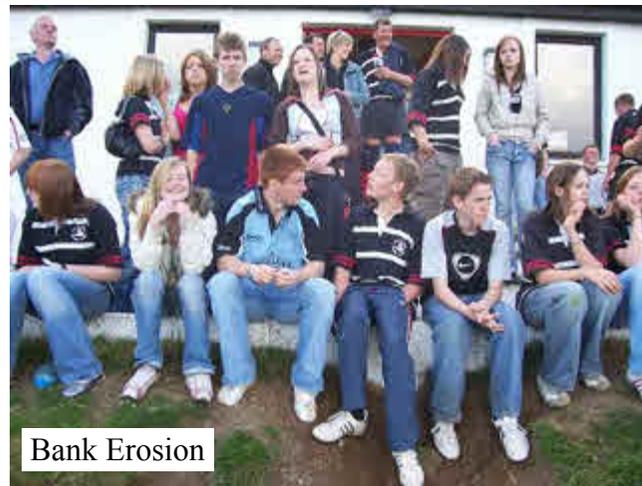
At bigger events players and spectators spill from the standing area down the grass slope onto the pitch. This interferes with the matches and erodes the bank supporting the building. This was partially solved by building a leaning fence but this reduced the standing area to such an extent that the flow of users to and from the building is severely compromised.

Bank Erosion

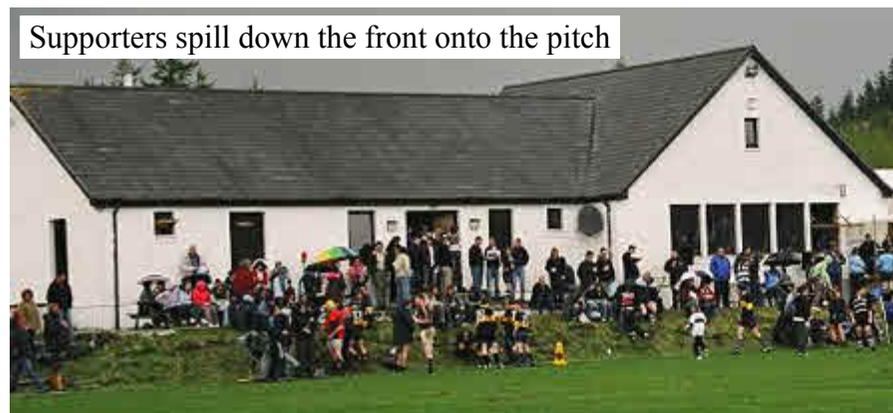
Supporters spill down the front onto the pitch

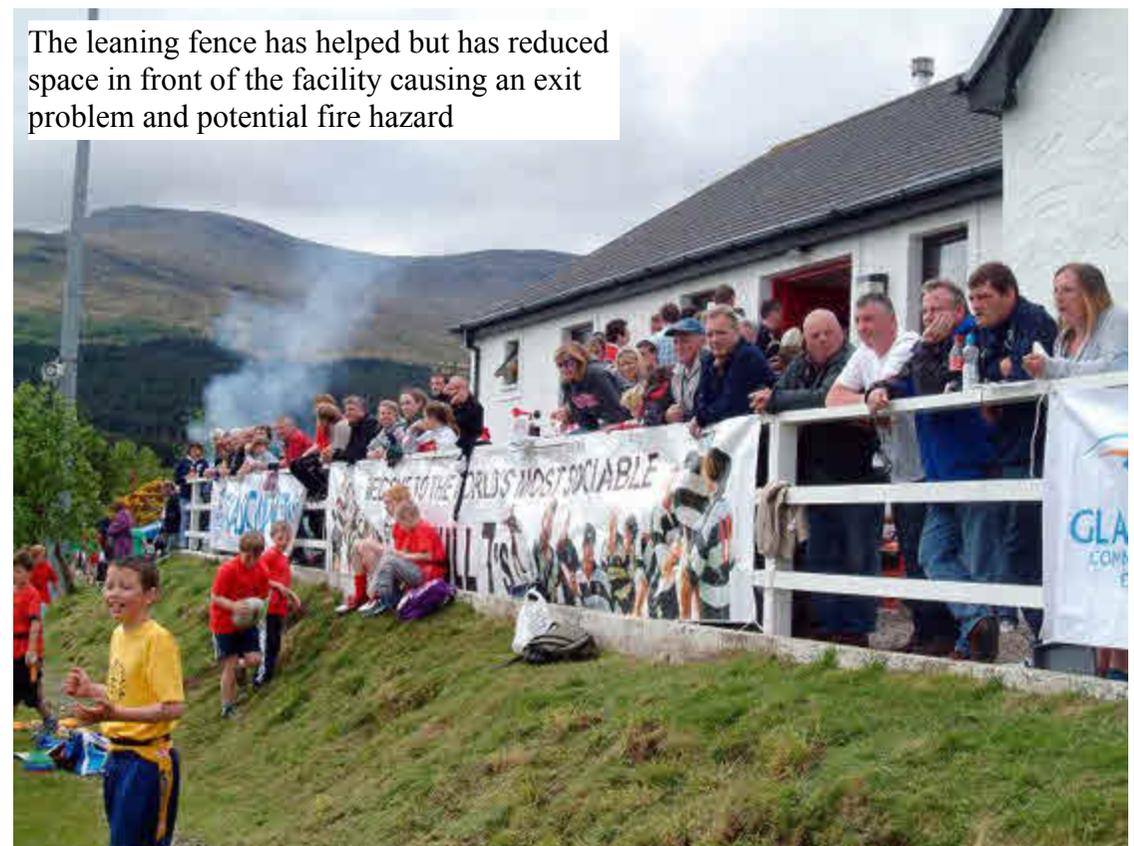
The leaning fence has helped but has reduced space in front of the facility causing an exit problem and potential fire hazard

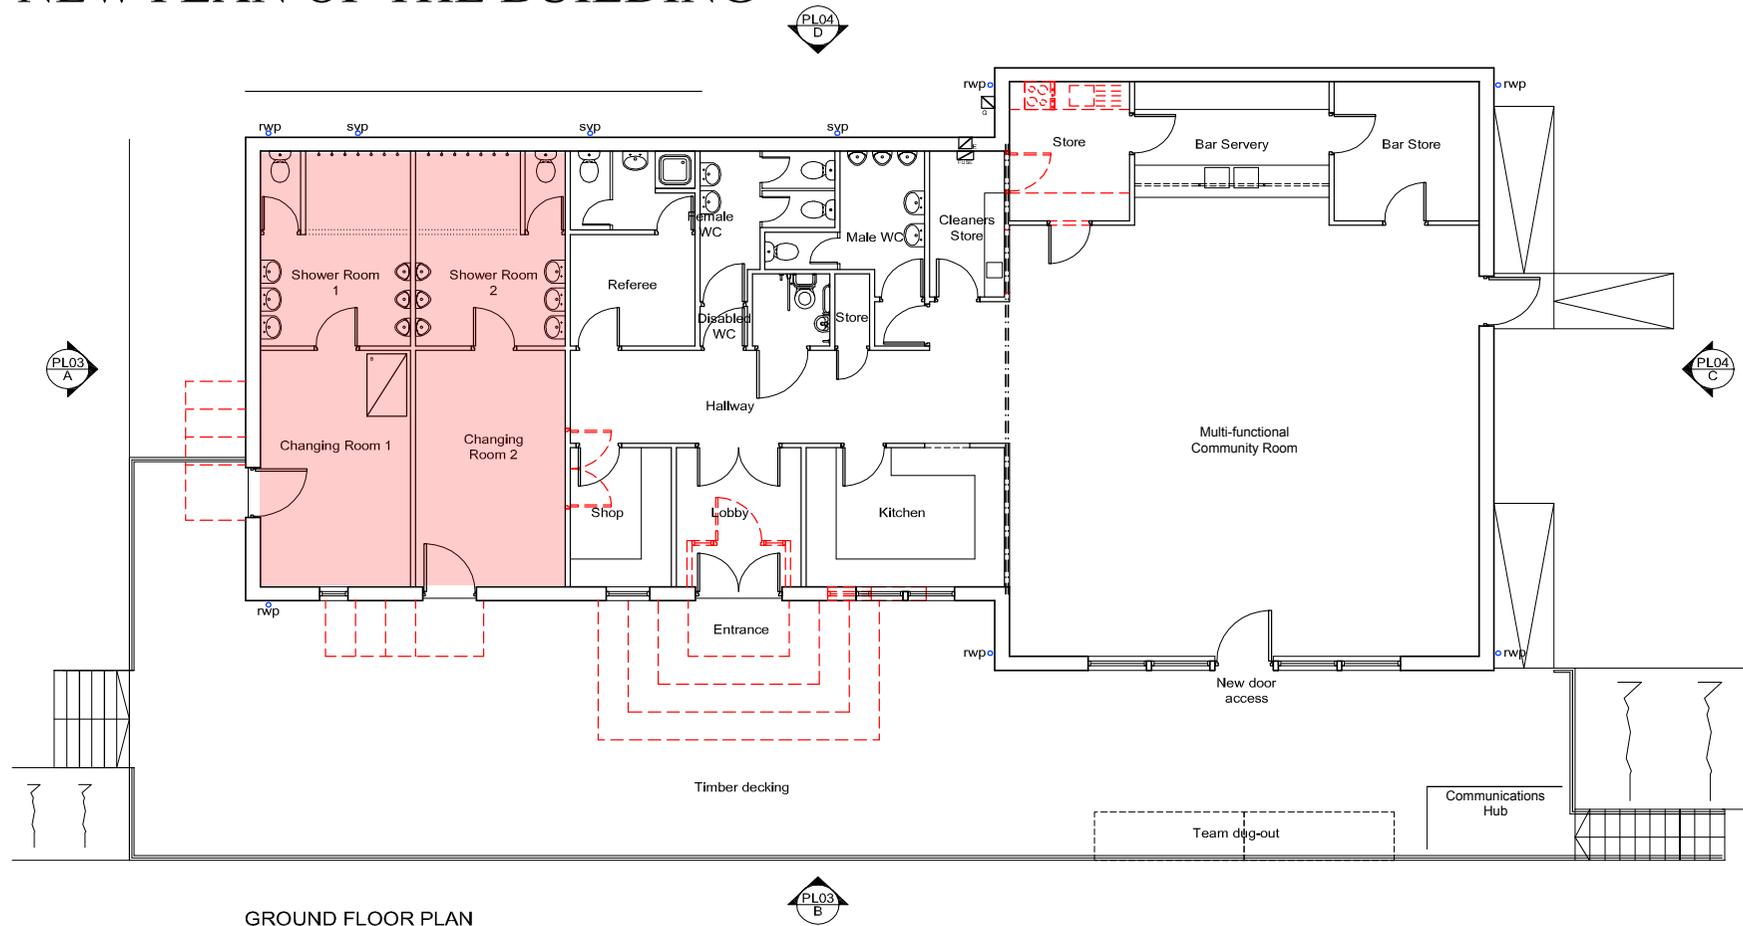
GROUND FLOOR PLAN

**Identified problem areas are shown in red** The new decking removes the dangerous steps from the entrance and changing rooms. The changing rooms are to be made good. The single door into the hallway is replaced with double doors. The new double door lobby is a much more efficient design for retaining building heat during the winter. The kitchen is moved from the rear to the front of the building. The new kitchen is larger and more accessible. With the front exterior ground level being the same as the interior floor level a new door access is introduced at the front of the multi-function community room for times of high use (for example the school sports day). All the badly insulated rotten windows and doors are to be replaced. The faulty render is to be replaced. The new shop will greatly assist in fundraising to run the facility. The new cleaners store and table store room will allow for the maximum diversity of users. The deck area provides a safe space in front of the building for supporters and contributes to a protected dugout for players during winter use. Suitable disabled access is now provided.

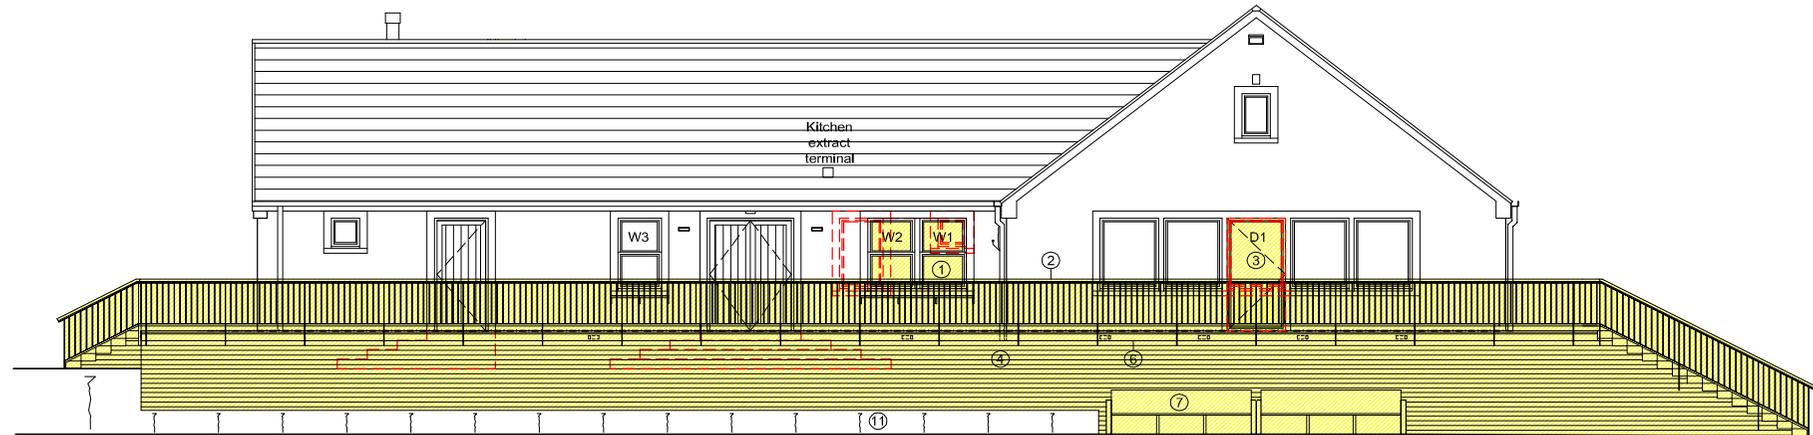
ELEVATION B - EAST

- Material Key:
1. New timber framed double glazed window / servery
  2. Timber handrail on steel balustrading
  3. New timber framed pattern 10 glazed door
  4. Masonry retaining / infill wall
  5. Millboard decking on continuous concrete structure
  6. Millboard fascia
  7. Team dug out seating
  8. Precast concrete steps

The elevations show the new raised exterior floor area that resolves the safety and access issues associated with the facility. Entry to the changing areas are now safe and accessible to all users. The surface of the raised area will be anti-slip surfacing i.e. Millboard or duradeck. Building warrants with specifications for full public use have been granted. Compliant protective barriers, steps and ramps around the external areas are all part of the proposals. The player dug out can also be seen. This gives protection from the prevailing westerly winds and rain which can give rise to extreme Mull weather. The exterior servery for the new kitchen is also illustrated. This will greatly help on busy sports days.

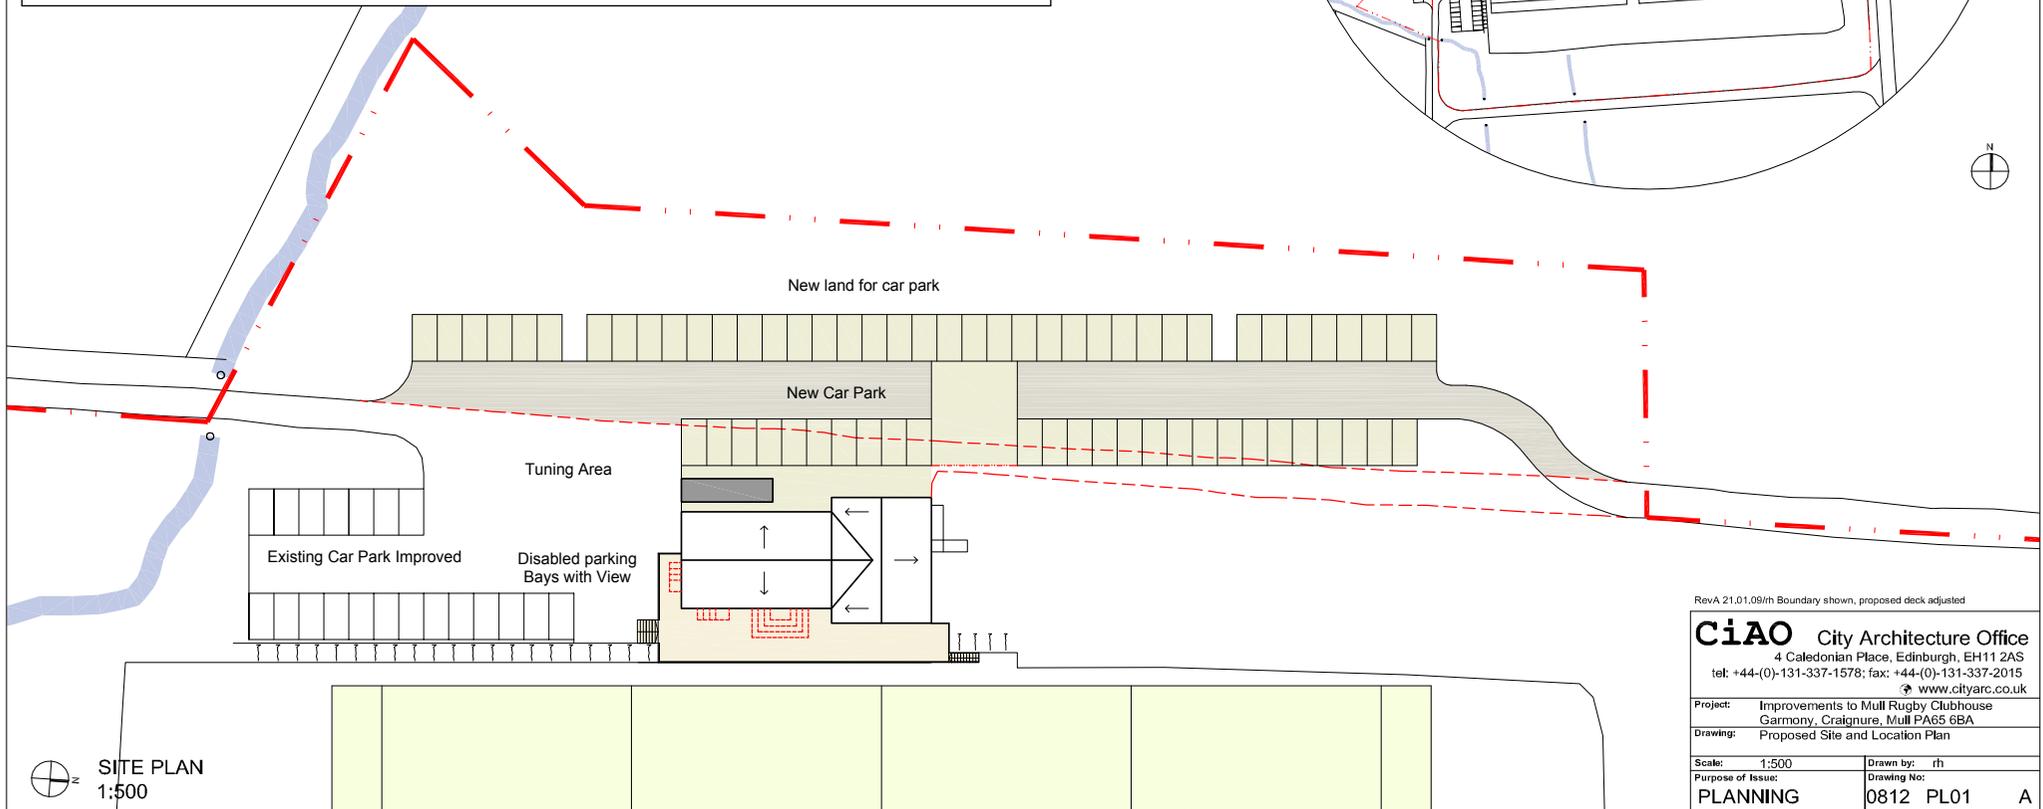
This year, with the help of a grant from Awards for All, the area of ground behind the clubhouse has been purchased from the Forestry Commission (Shown with the thicker dotted red line).

Having the new parking area will allow the existing parking to be improved. Solid surfacing will provide for disabled parking bays, car park markings, a turning and unloading area. The area will have full external lighting to help safe wayfinding. This makes the facilities accessible for all particularly in the winter months.
